SPICKET RIVER GREENWAY DESIGN GUIDELINES

Lawrence, Massachusetts

Copley Wolff Design Group
Landscape Architects & Planners
160 Boylston Street • Boston, MA

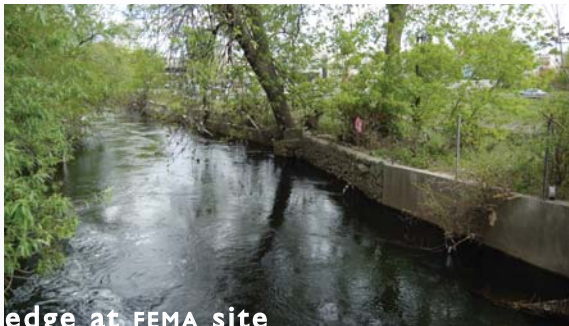
edge at FEMA site

- The banks of the Spicket along the Lawrence Department of Public Works (DPW) site lack vegetation and are eroding. There is currently no river access at this site, but could be a potential location for a small pedestrian bridge to cross the river and continue the river greenway along Erving Avenue.

- The northern river banks become higher and steeper than the southern bank along Marion Avenue, which is lower and highly susceptible to seasonal flooding. Hampshire Street is often blocked off during spring floods.

- Short concrete retaining walls are in disrepair. There are muddy deposits along the bank and several buildings come up right to the river's edge.
- The most visually accessible locations are the river and the most sparsely vegetated areas, which have the least amount of collected refuse and illegal dumping.

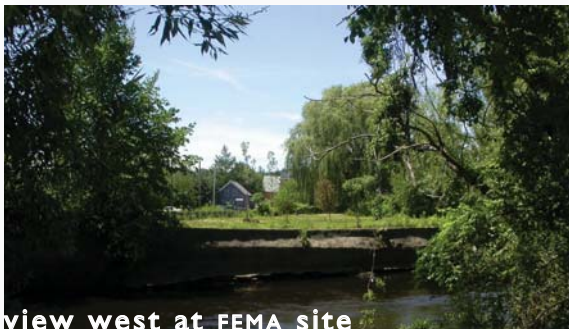
view west at FEMA site

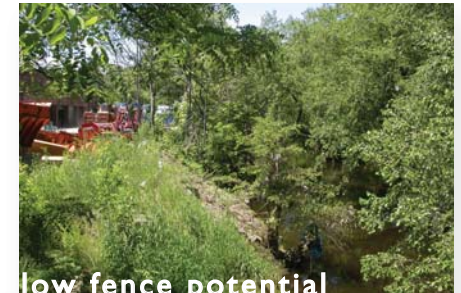
low fence potential

- A two foot high guardrail along Erving Avenue separates the street from the densely vegetated and very steep riverbank, contributing to extremely limited visual and physical access to the river.

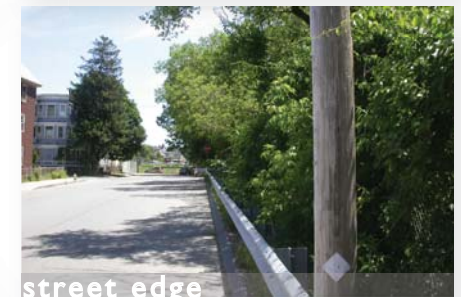
street edge

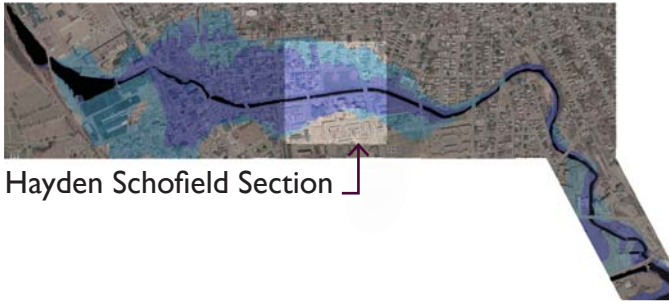
Hayden Schofield Section

- Hayden Field, a community park with ball fields and swings, is only a few feet in elevation above the Spicket's average high water level resulting in seasonal flooding.

- There is an existing path along the Spicket River at Hayden Field, providing community access to the river; however, this path is under water during floods.

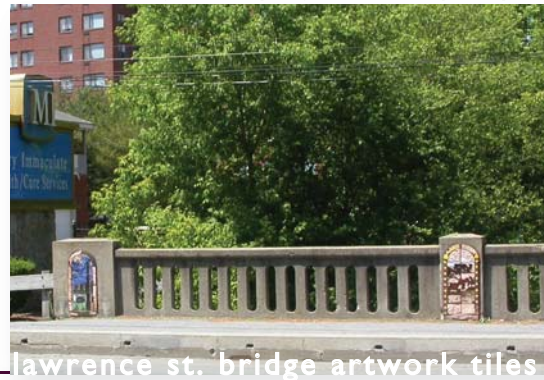
Lawrence st. bridge artwork tiles

- The Lawrence Street bridge features community artwork tiles. The river greenway could provide opportunities to display more of the work of local school children and artisans.

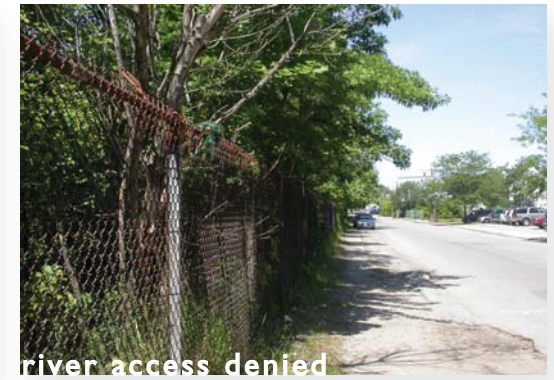
river access denied

- The Lawrence Street bridge provides an easily accessible and scenic river overlook.
- A dirt pedestrian path lined with an eight foot high chain-link fence runs along the southern bank of the river on Marion Avenue. Many drivers and pedestrians are unaware of the river's presence due to the thick layer of vegetation separating one from the river. This fence lined path along the river's bank is reminiscent of an abandoned lot or retention basin and has become a popular area for illegal dumping over the past years.

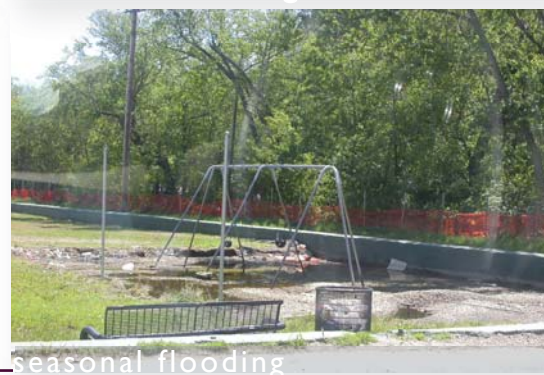
seasonal flooding

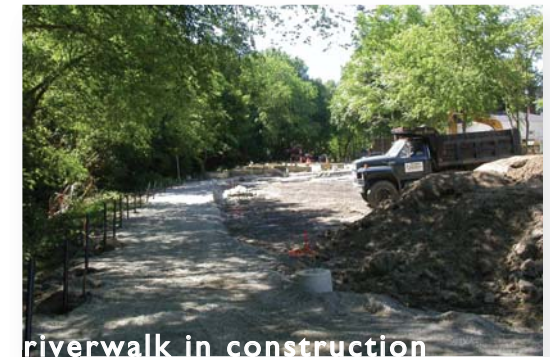
riverwalk in construction

- Brook Street Park construction was completed in June 2006.
- A river access point behind the playground and basketball court have potential to become a canoe and kayak landing as well as a fishing site.
- Brook Street Park is not prone to flooding because it is located on high ground with a newly rebuilt retaining wall that separates the park from the river's edge.
- Recreational features of the park include a patio, picnics areas, a shade pavilion, a fountain and play fields. The park will also feature a series of paths designed to connect to the future river greenway.
- At this site, the river curves southward creating a bend that becomes a collection site for garbage and large debris.
- There are small rapids in the river at the southern end of park.

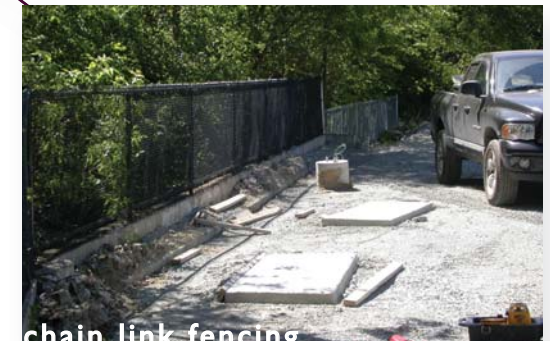
chain link fencing

located in areas of high vertical separation

Typical river edge conditions should include protective safety fencing at elevated grade changes and low wood rail fencing at sections of gentle edge transition.

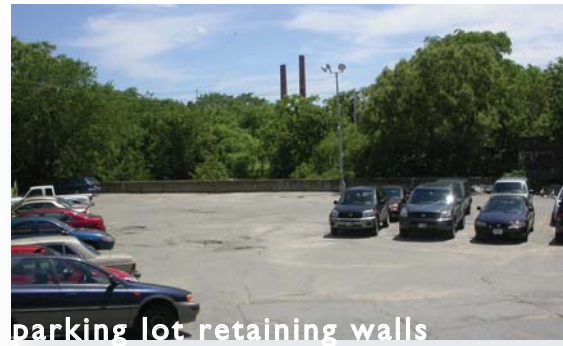
parking lot retaining walls

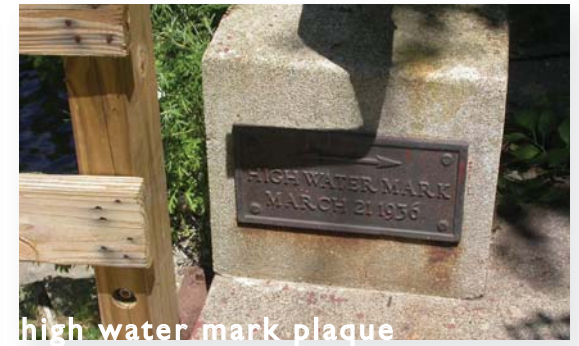
high water mark plaque

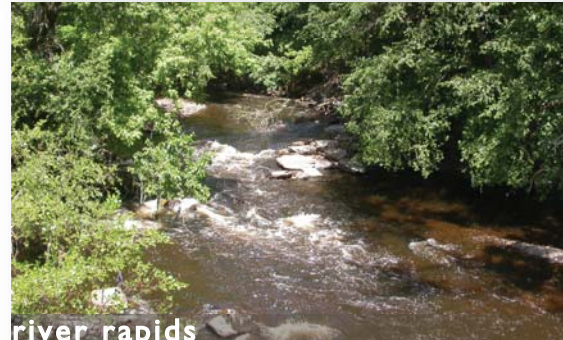
river rapids

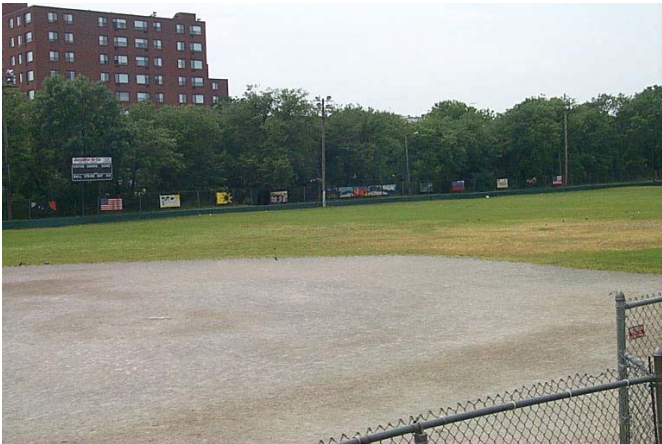
Existing Playfield: Poor drainage after flood event

The playfield itself is prone to seasonal flooding and because existing drainage system does not function properly, recreational use is limited. It is suggested that an under drainage system be implemented in order to increase use and community value of the playfields.

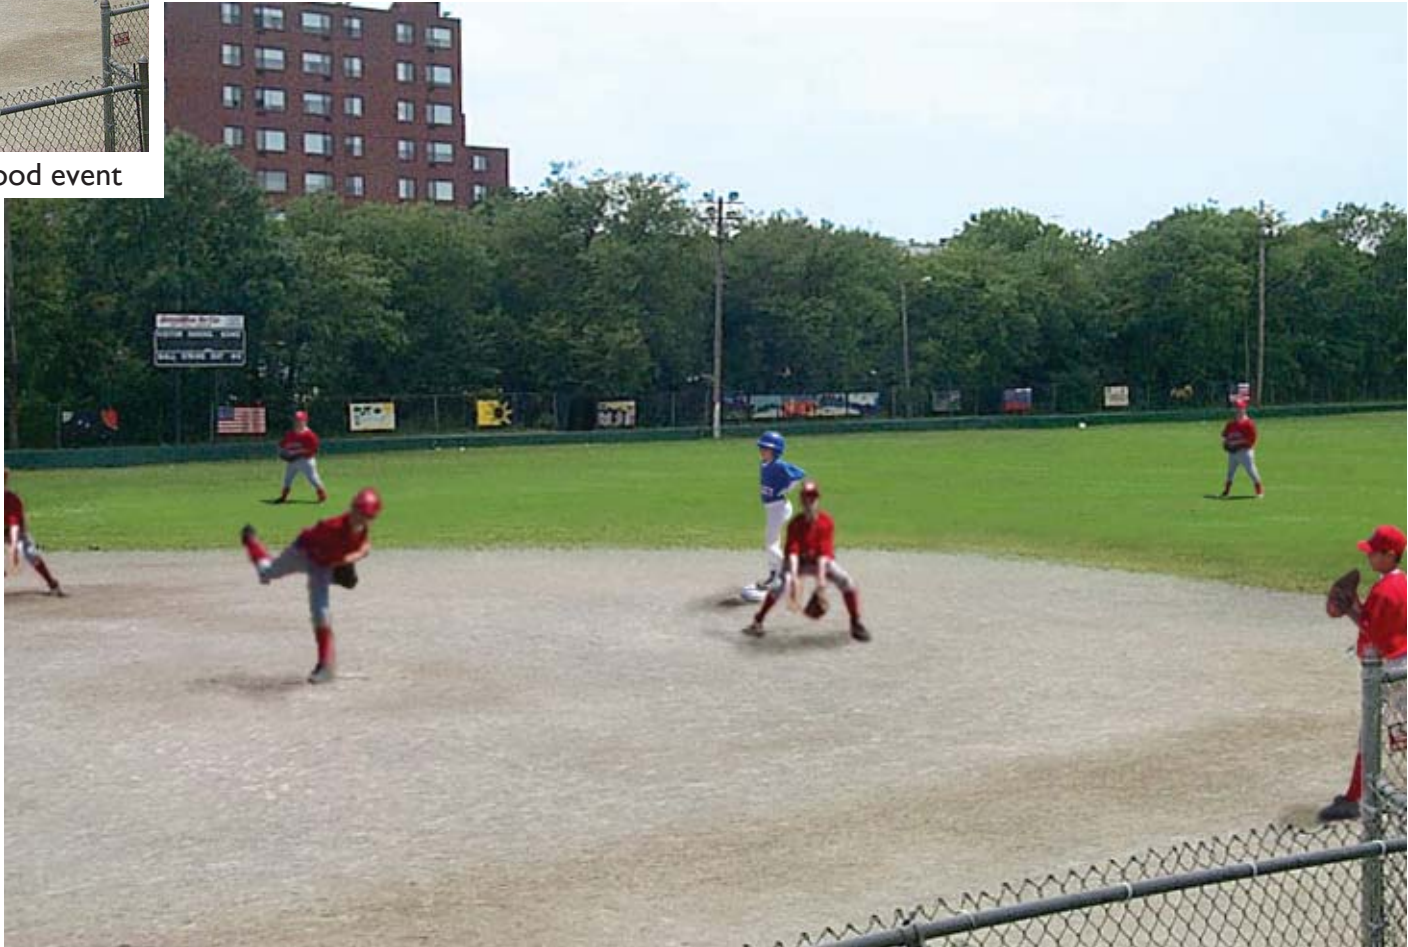
Playfield Potential - Application of under drainage system resulting in better drained soil and sod

The field would greatly benefit from the installation of well drained sub-base with an underdrains system. This would allow the field to continue to act as an area of flood storage while more quickly return to an active playfield once the flood waters have diminished. As part of the process, the field should be sodded and maintained with a seasonal irrigation system.

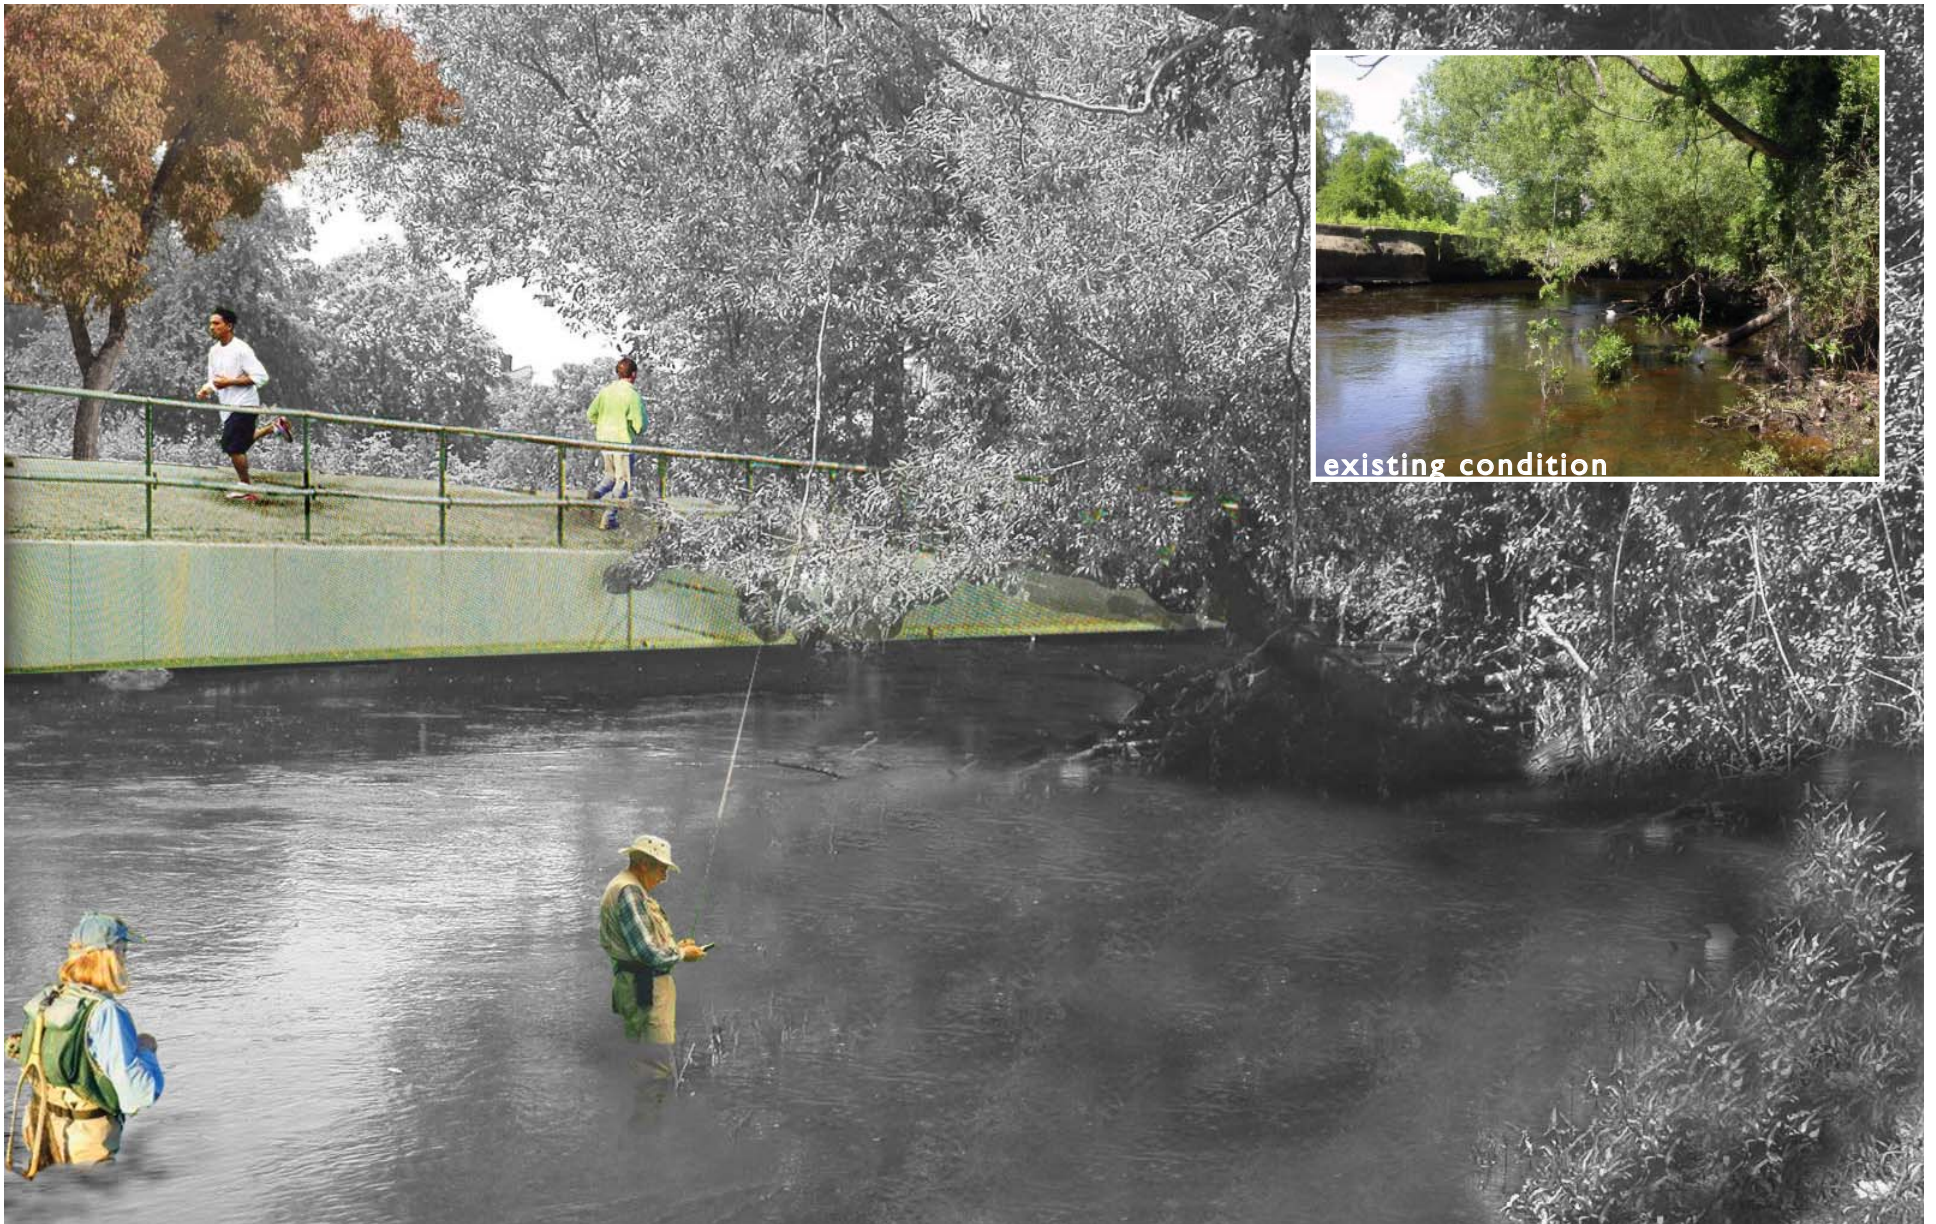
Strengthen pedestrian access along the banks of the river and encourage recreational uses.

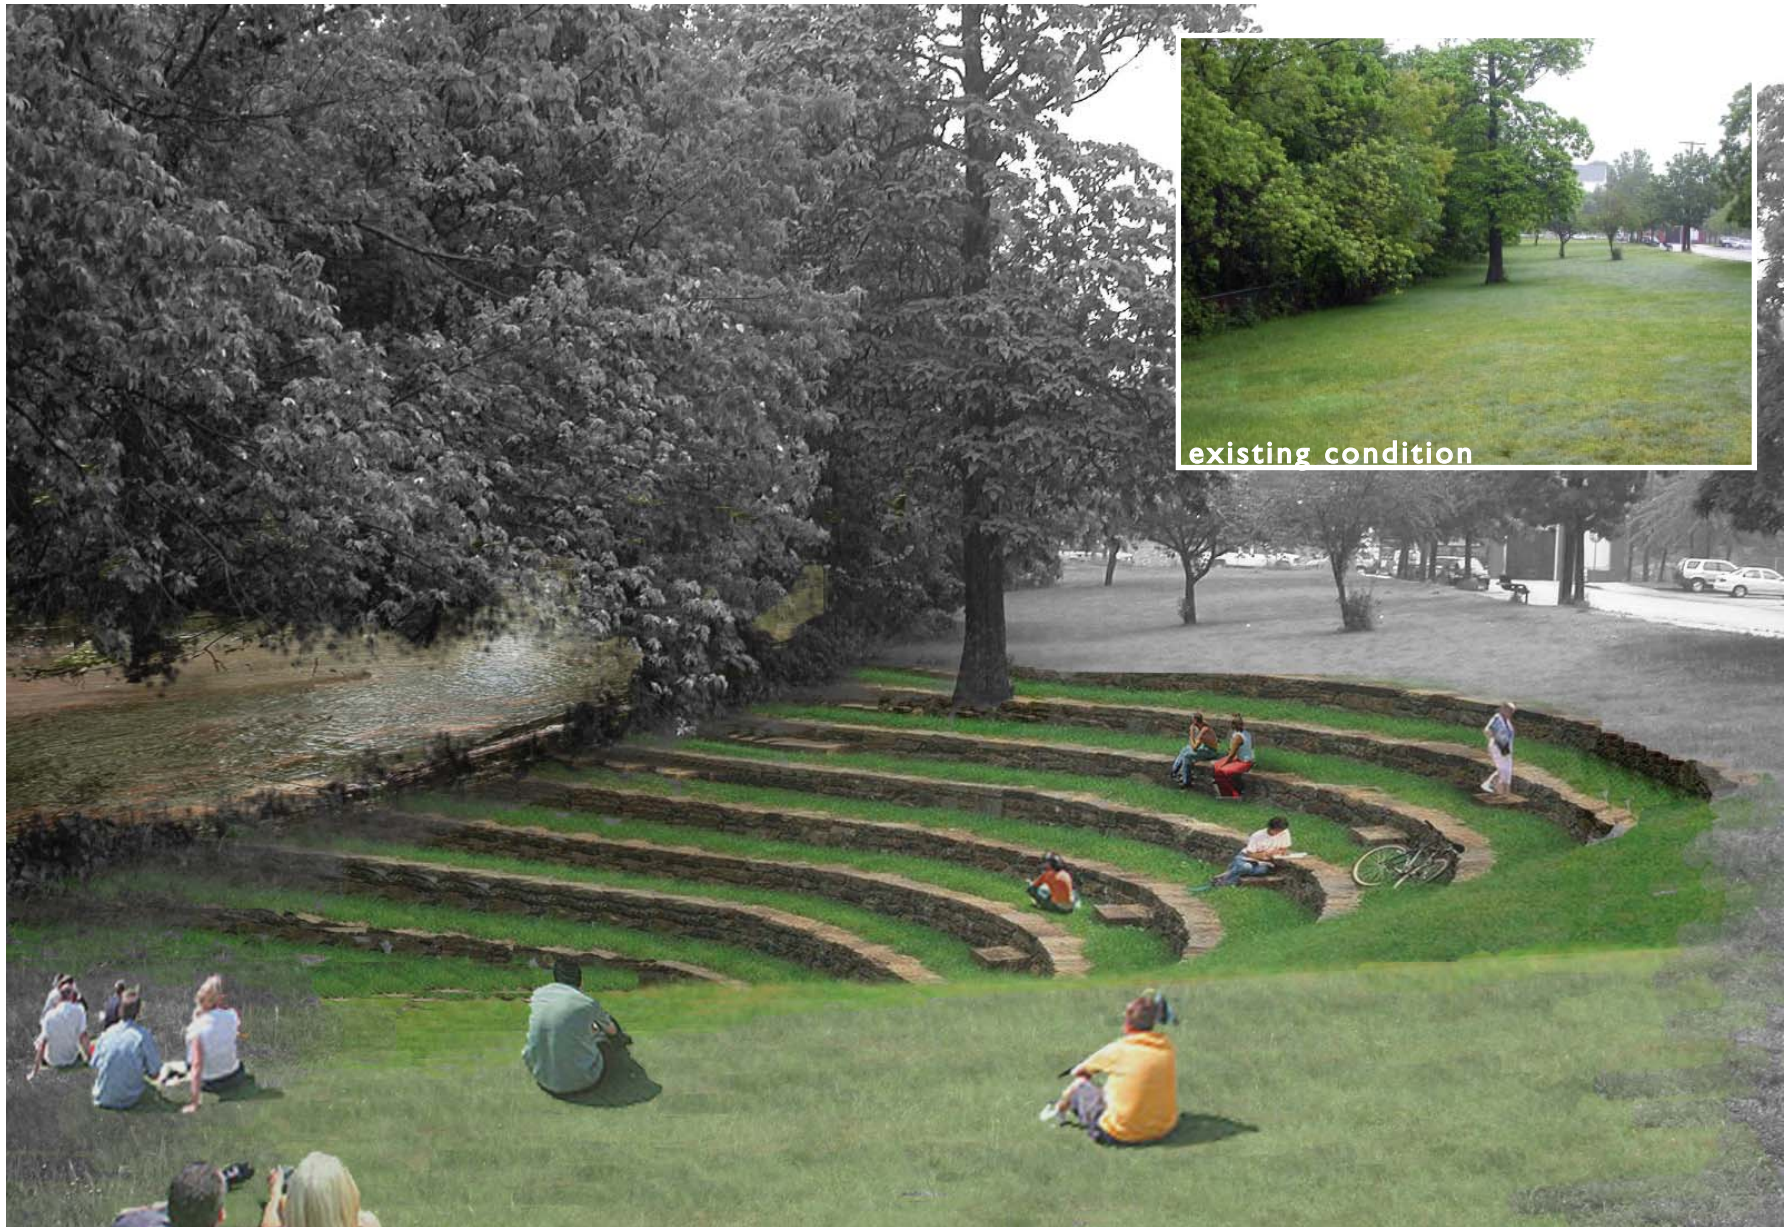
Enhance river access and connections at existing public open spaces.

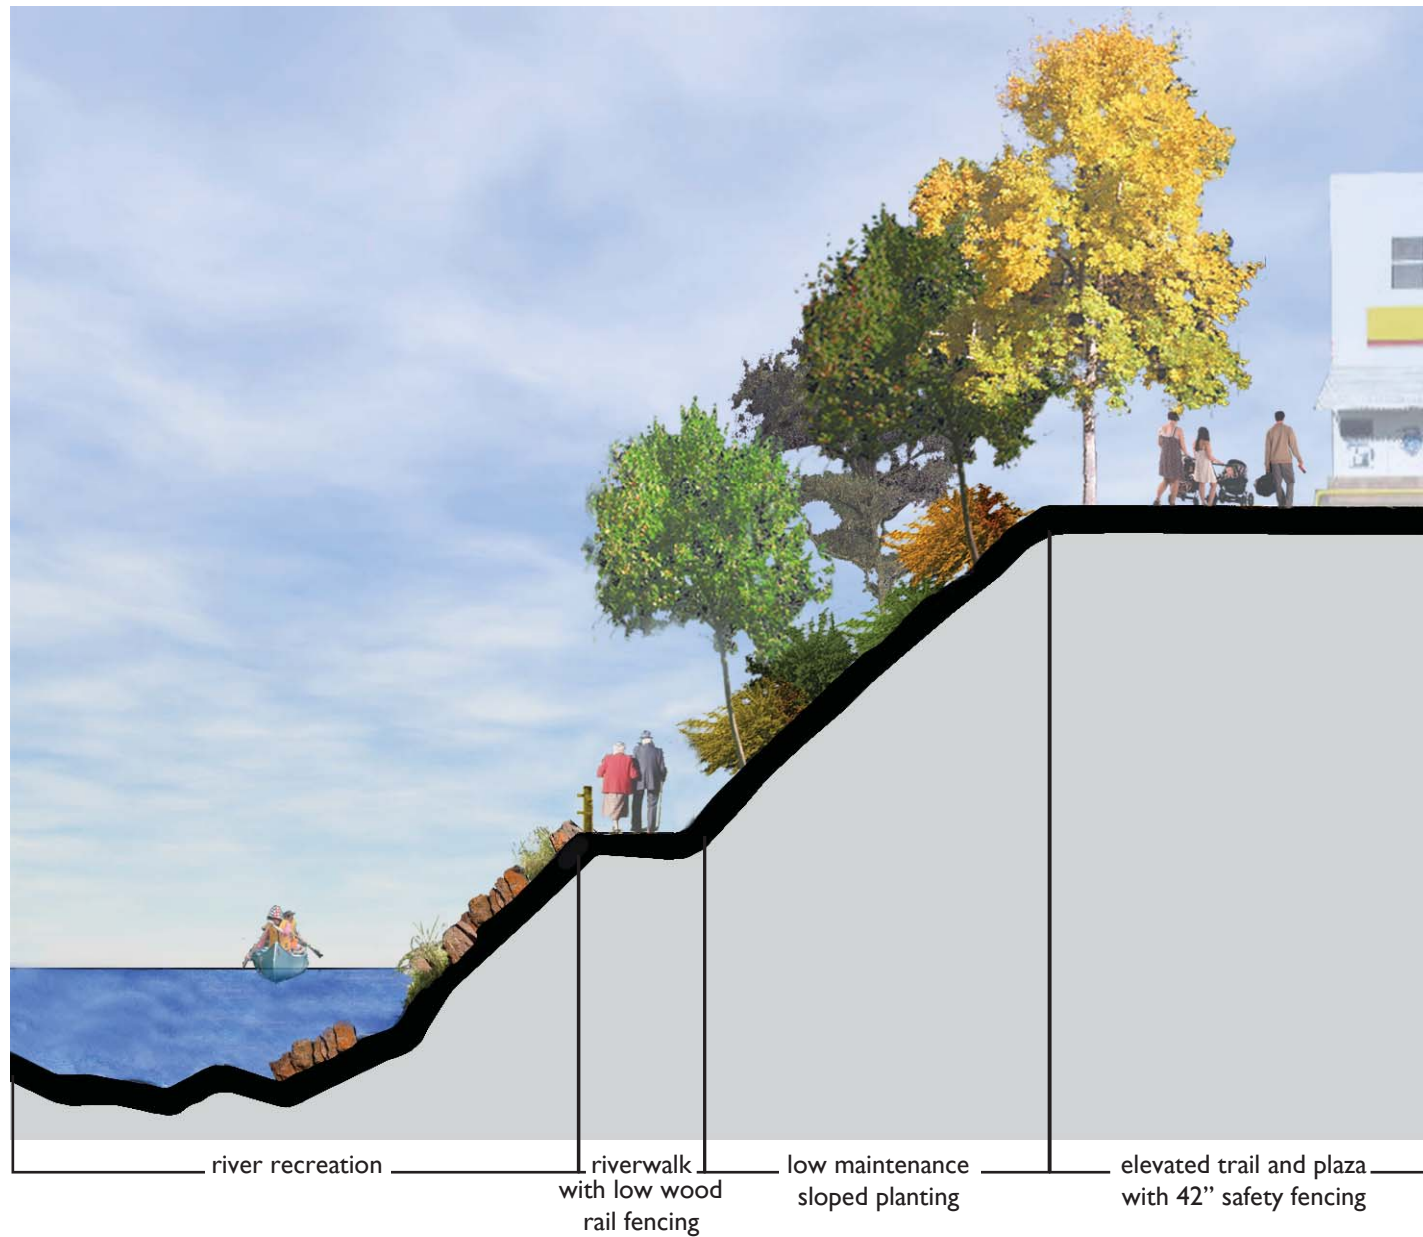
Typical river edge conditions should include protective low wood rail fencing at sections of gentle edge transition. Trail options would allow users to actively use portions of the trail depending on river level and seasonal flooding.
